# “Influence of Artesian Groundwater Pressure on Foundation Stability and Design”

<sup>1</sup>Arun Kumar, <sup>2</sup>Prof. Ashish shrivas,  
<sup>1</sup>M.Tech Student, <sup>2</sup>Assistant Professor,  
<sup>1,2</sup>Civil Engineering Department,  
<sup>1,2</sup>Vikrant University, Gwalior, (M.P.) India

The research focuses on the bridge constructed across the Chambal River on the Ater–Jaipur Highway. The site is characterized by soil strata containing artesian groundwater at varying depths. The foundation design is based on two key considerations: first, preventing bed boiling (quick condition) even under maximum scour conditions; and second, ensuring the availability of a minimum thickness of soil cushion between the foundation level and the artesian-bearing stratum during construction.

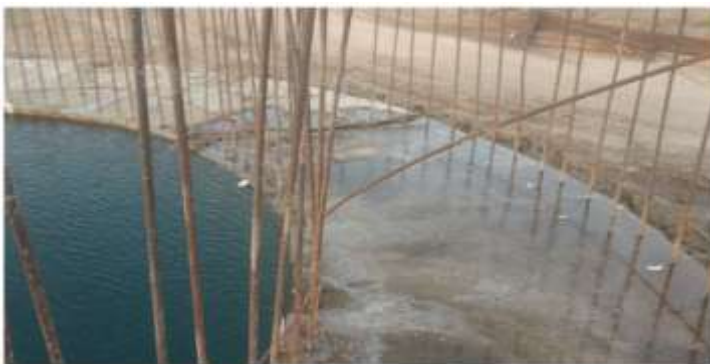
Fig 1:- Artesian Water Pressure

Artesian pressure develops when groundwater is confined between impermeable soil or rock layers, creating pressure within the aquifer. Understanding these conditions presents a significant challenge for civil and geotechnical engineers responsible for foundation design and construction. This dissertation provides a detailed examination of artesian groundwater conditions and their influence on foundation design.

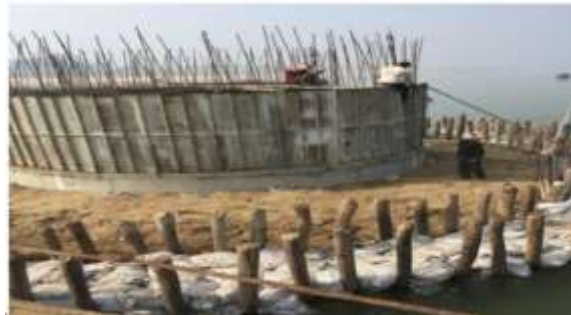
The deep foundations where low water pressure exists, the false steining is constructed to counteract the artesian pressure. This is the solution which protects the bridge structures over entire service period. The local artesian head is relieved by the construction of false steining and this requires expert technical workforce. The

wooden piles are provided below at 300 mm/cc spacing. This results into water tight surroundings and thus responsible for the stability of the soil. . The platform is constructed with double the diameter of the well and piles are driven along the boundary and sand bags are placed between the piles. This behaves like a coffer dam.

**Fig. Construction of false Steining with cofferdam**

The afflux effect can be neutralized by providing , false Steining with thickness of 300 mm and 4 m height which can be dismantled at the designed top level of the well cap.

- We improved the technique of construction under flowing artesian condition by concreting the structure, drilling the wooden piles and controlling the river water by constructing the cofferdam.
